LETTER REPORT
FOR
MOSCHIANO PLATING COMPANY
CHICAGO, COOK COUNTY, ILLINOIS
TDD: S05-9709-002
PAN: 7P0201RA

Re: Moschiano Plating
Chicago, Cook County, Illinois
TDD: S05-9709-002
PAN: 7P0201RA

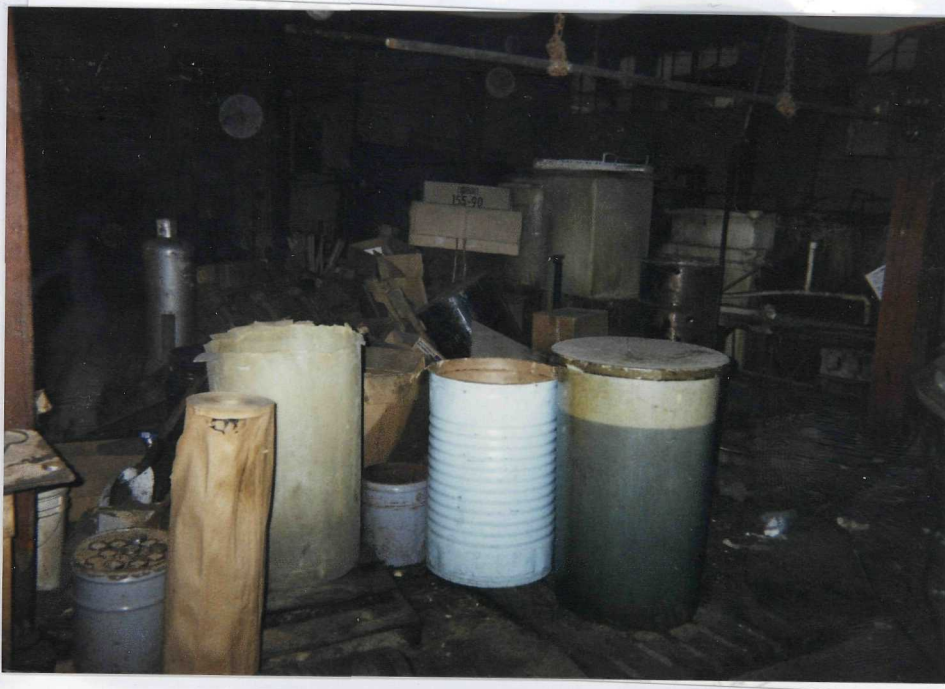
SUBJECT: Drums in center of plating area, vats in background.

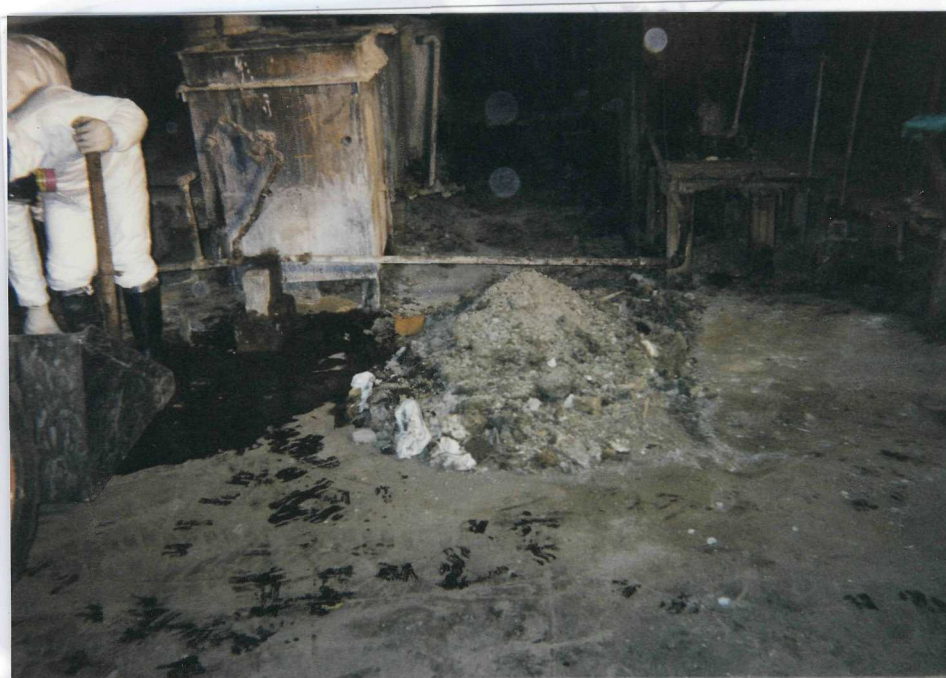
SUBJECT: Plating solids from underneath catwalk.

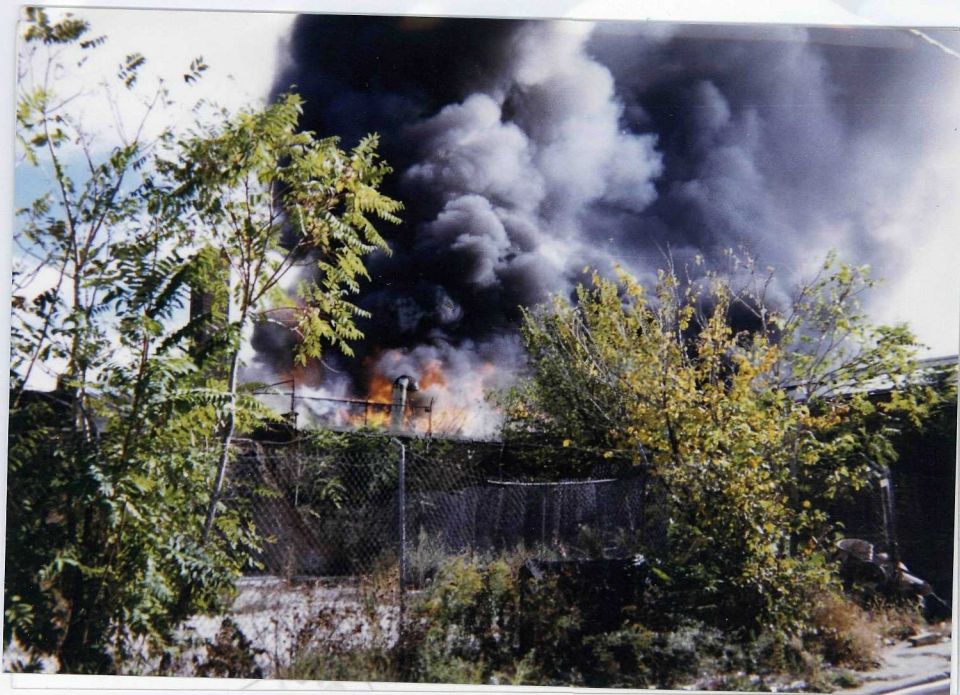
SITE: Moschiano Plating Company
LOCATION: Chicago, IL
SUBJECT: Fire on roof above plating area.

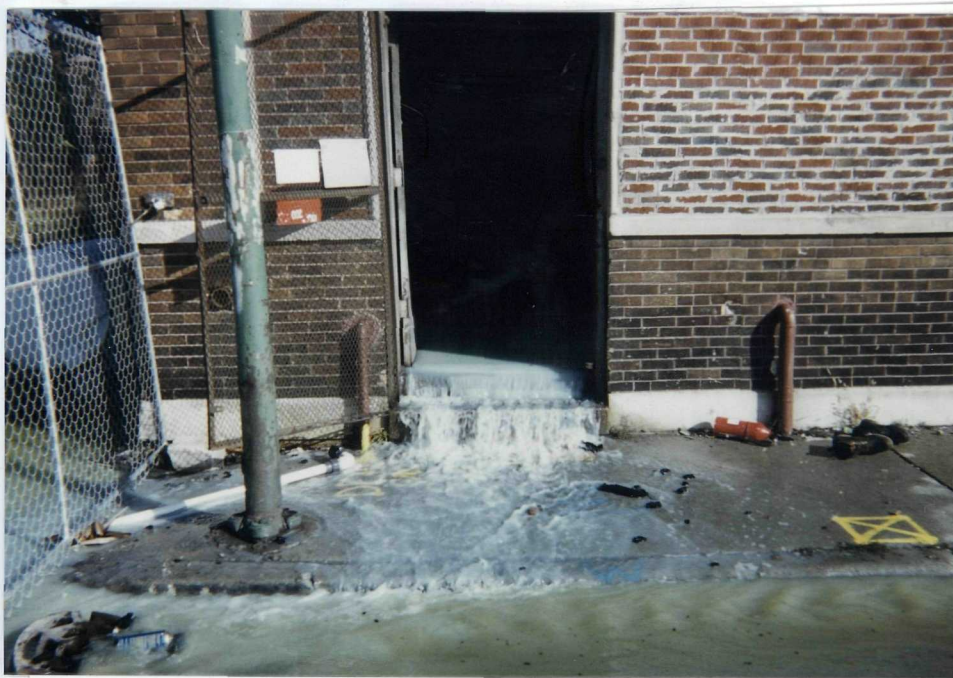
SITE: Moschiano Plating Company
LOCATION: Chicago, IL
SUBJECT: Water flowing out of door on Mozart Street (note green tint).

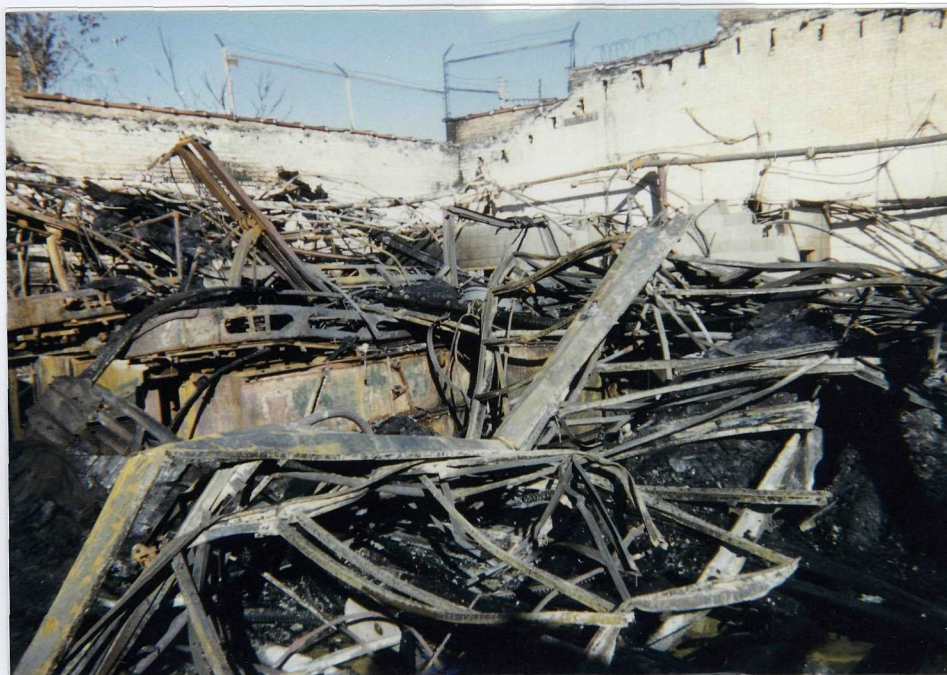
SUBJECT: Steel debris and vats the morning after the fire.

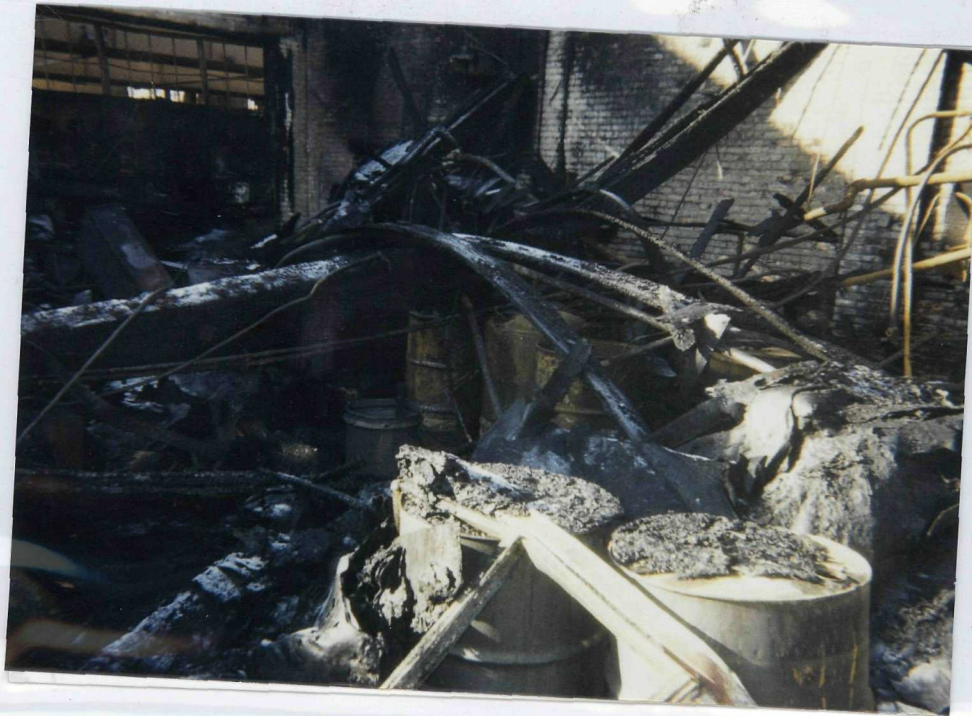
SITE: Moschiano Plating Company
LOCATION: Chicago, IL
SUBJECT: Collapsed roof on drums.

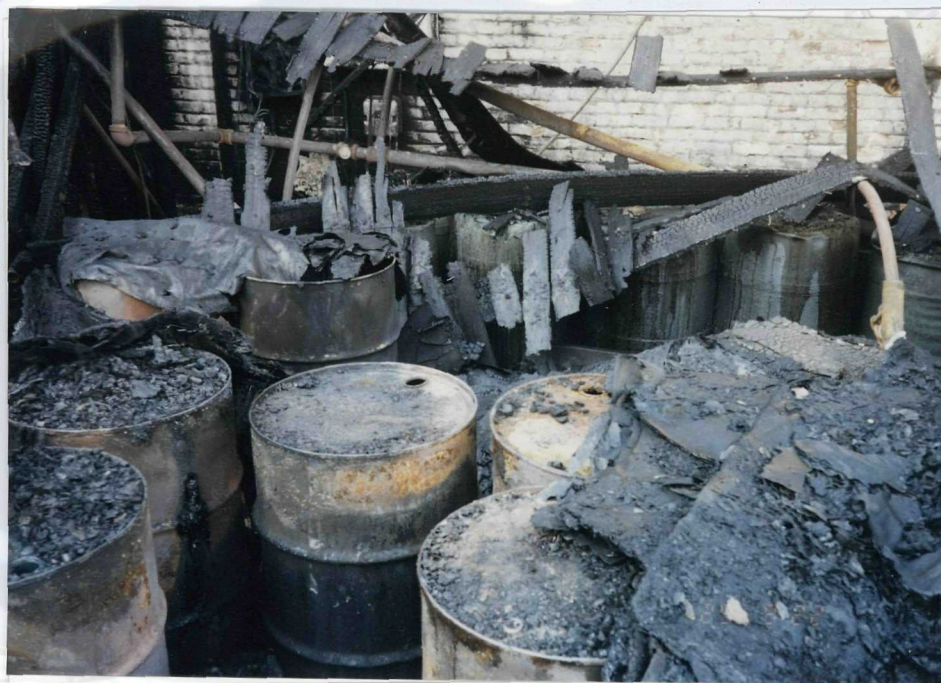
SITE: Moschiano Plating Company
LOCATION: Chicago, IL
SUBJECT: Drum staging area; poly drums melted-down in background.

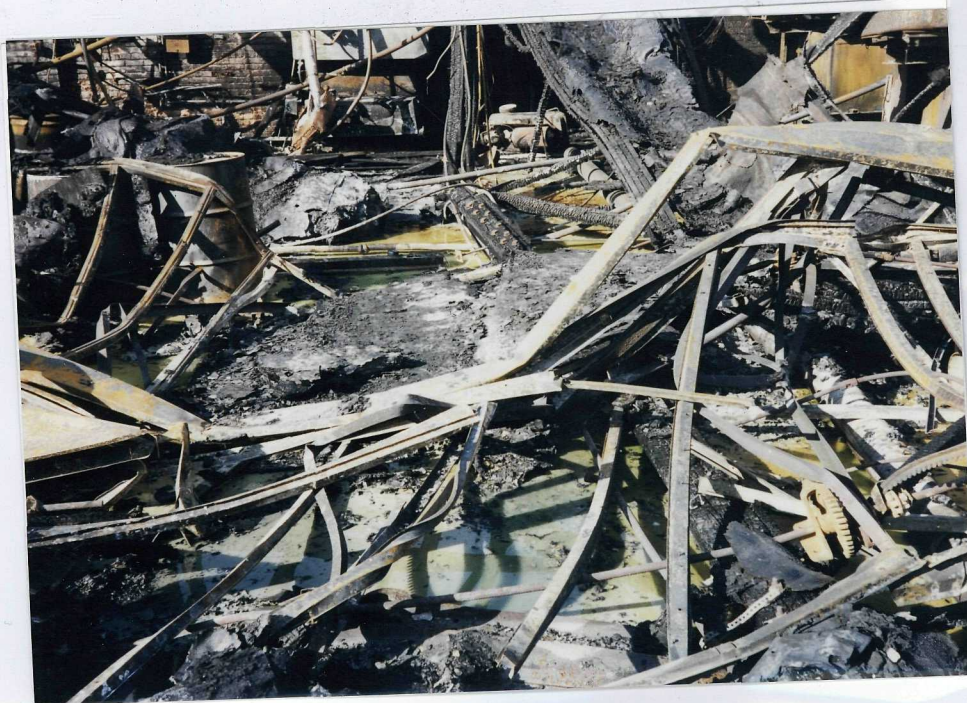
SUBJECT: Fire debris and liquid on floor.

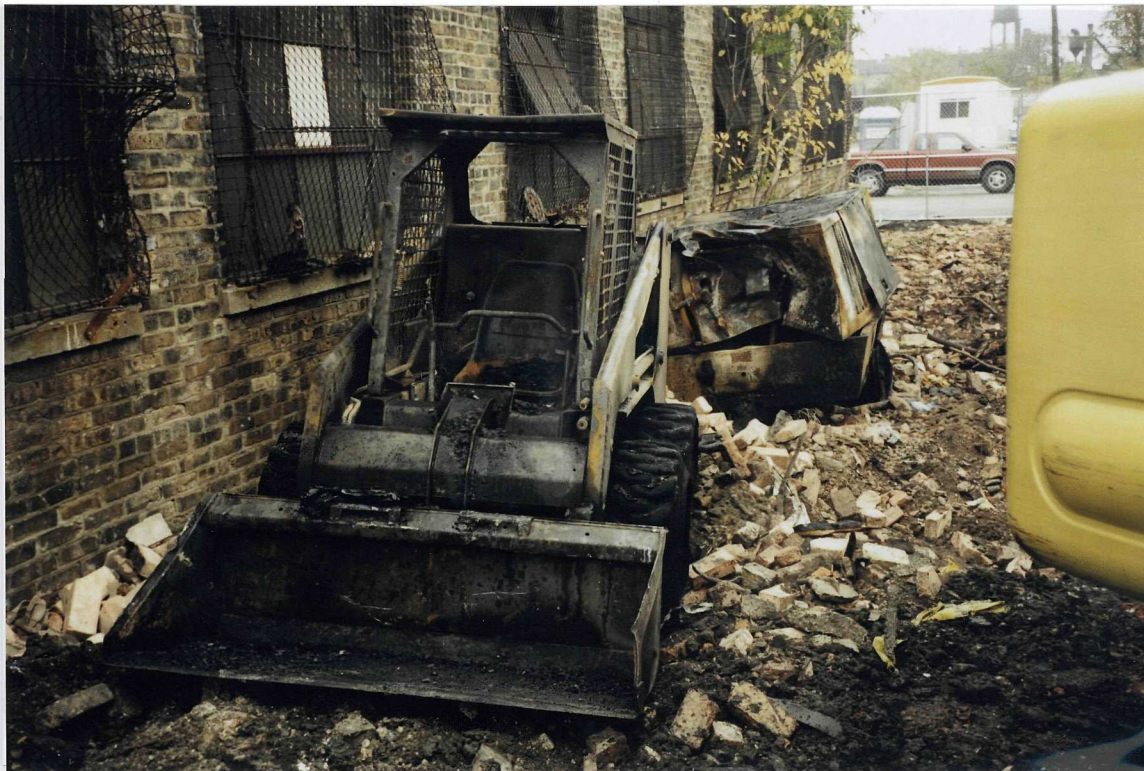
SUBJECT: Charred bobcat and compressor moved to north yard.
